# U.S. Chemical Safety and Hazard Investigation Board (CSB) Investigation Exercises – Facilitator

## Kaltech Industries Building Explosion

New York, NY, April 25, 2002

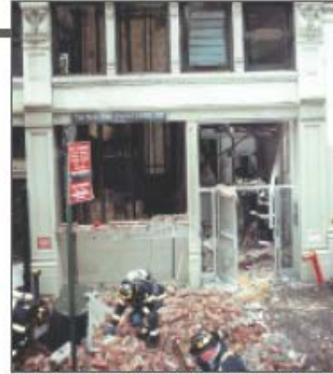
The explosion blew out windows up to the fifth floor and showered the street below with building debris.

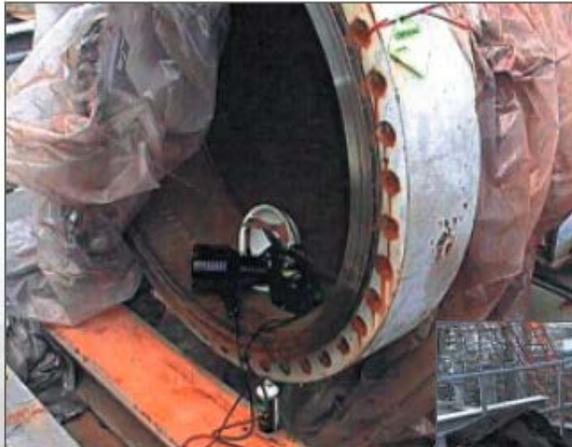
Large open pipe end where the two victims were working

tenance project, in which some process equipment had been temporarily removed. The equipment removal left the pipe connected into the process unit but open to the air at one end. The two victims, both skilled and experienced workers, were inspecting the inside of the 48-inch open pipe end to gauge the effectiveness of an earlier cleaning effort. While the men worked, nitrogen gas was being used to purge air and moisture from the unit, protecting the chemicals inside.

The CSB investigation report noted that it is important to look beyond an immediate task and anticipate secondary hazards that may not be obvious. In this case, operators did not evaluate the risks caused by the nitrogen purge to the workers downstream, and hazards at the open pipe end were not recognized. The investigation concluded that a hazard evaluation likely would have led operators to post warning signs at the pipe opening and prevented the accident.

After the accident, managers said they did not know that the workers were going to perform a black light inspection of the pipe, which led to the creation of a temporary enclosure. However, the CSB found that the open pipe end itself presented a hazard, and any worker who simply leaned into the open pipe could have been overcome, depending upon the wind and other conditions.

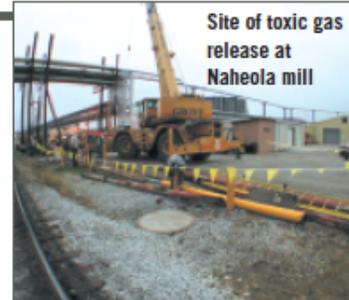
Site of toxic gas release at Naheola mill

The hydrogen sulfide gas leaked through the seal of a fiberglass manhole cover near the Burkes construction workers. All ten victims were exposed to the escaping gas. Three workers were overcome almost immediately and fell to the ground. Instead of evacuating the area, three of the remaining workers attempted to drag the fallen men to fresh air. Two of them passed out in the course of assisting the others. Mill workers farther away saw the victims collapsing and called in emergency help.

There had been earlier indications of problems with the fiberglass manhole cover from which the hydrogen sulfide escaped. Employees reported previous occasions where another toxic gas, chlorine dioxide, leaked through the seal

of the manhole cover. However, these leaks were not reported or investigated as near-miss incidents. Maintenance personnel repaired the leaks but were unable to find a permanent solution to the problem. Had the earlier incidents been investigated, it is likely that management would have redesigned the sewer system opening, the CSB said.
